# Manhole Inspection Summary

Manhole # S21C\_\_042MH

Insp Date: **9/19/07 9:18 AM**

**Location** Address: **531 FULTON AVE**

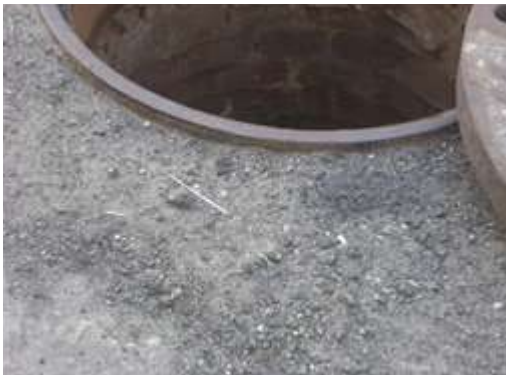
Defect 1

Diameter: **24** (in.) Length: (in.) Dist A/B Grade: **1** (in.)

GRADE ADJ

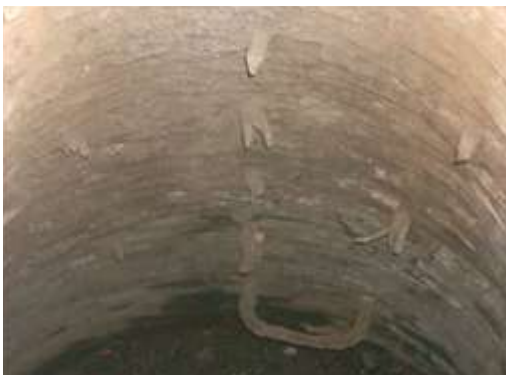
Defect 2

Count: **4** Missing: **1** ☒ **Corroded**

MISSING AND CORRODED STEPS

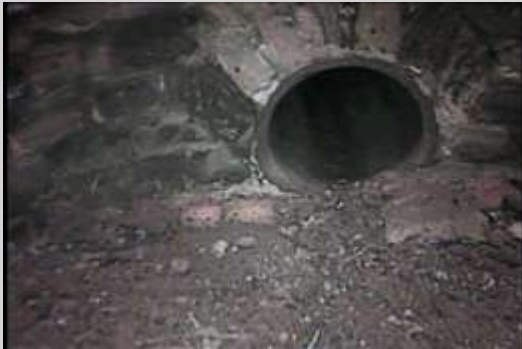
12 O'Clock Outflow

8 in. Circular Gravity Sewer  
Pipe Out @ 12 O'Clock

Pipe Height: **8.4** (in.) Rod and Bar (Angled)  
Pipe Material: **Clay** ☐ Pipe Lined  
Invert Depth: **9.41** (ft.) Flow Characteristics: **None**  
Deposits: ☒ None ☐ Mud ☐ Sludge ☐ Debris ☐ Grease  
Silt Depth: (in.) Deposits Extent:  
Infiltration: **None** Pipe Seal Cond: **Sound**

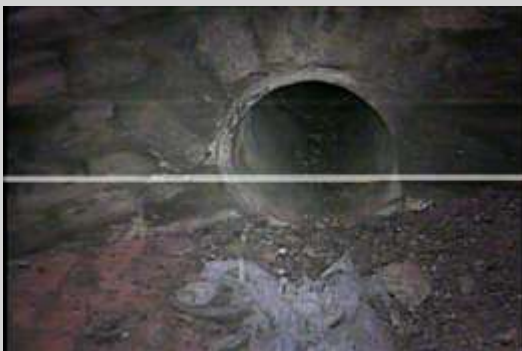
6 O'Clock Outflow

8 in. Circular Gravity Sewer  
Pipe Out @ 6 O'Clock

Pipe Height: **8.4** (in.) Rod and Bar (Angled)  
Pipe Material: **Clay** ☐ Pipe Lined  
Invert Depth: **9.40** (ft.) Flow Characteristics: **None**  
Deposits: ☒ None ☐ Mud ☐ Sludge ☐ Debris ☐ Grease  
Silt Depth: (in.) Deposits Extent:  
Infiltration: **None** Pipe Seal Cond: **Sound**
